**FRONT YARD SET BACK TREE REMOVAL  
REQUEST**

**December 2017**

***Subject: Tree Survey and Arborist Report for the Pemm Place Project, Santa Barbara, California***

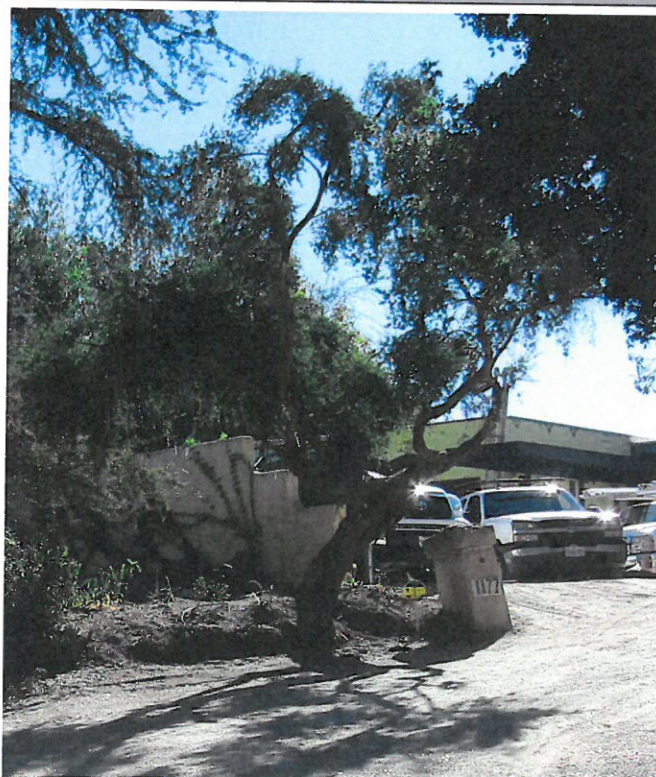
**PHOTO INVENTORY**

*Tree Species:* *Leptospermum laevigatum*, *Common Name:* Australian Tea Tree

*Reason for Removal:* New house construction, tree will block driveway, and Fire Dept. needs access.

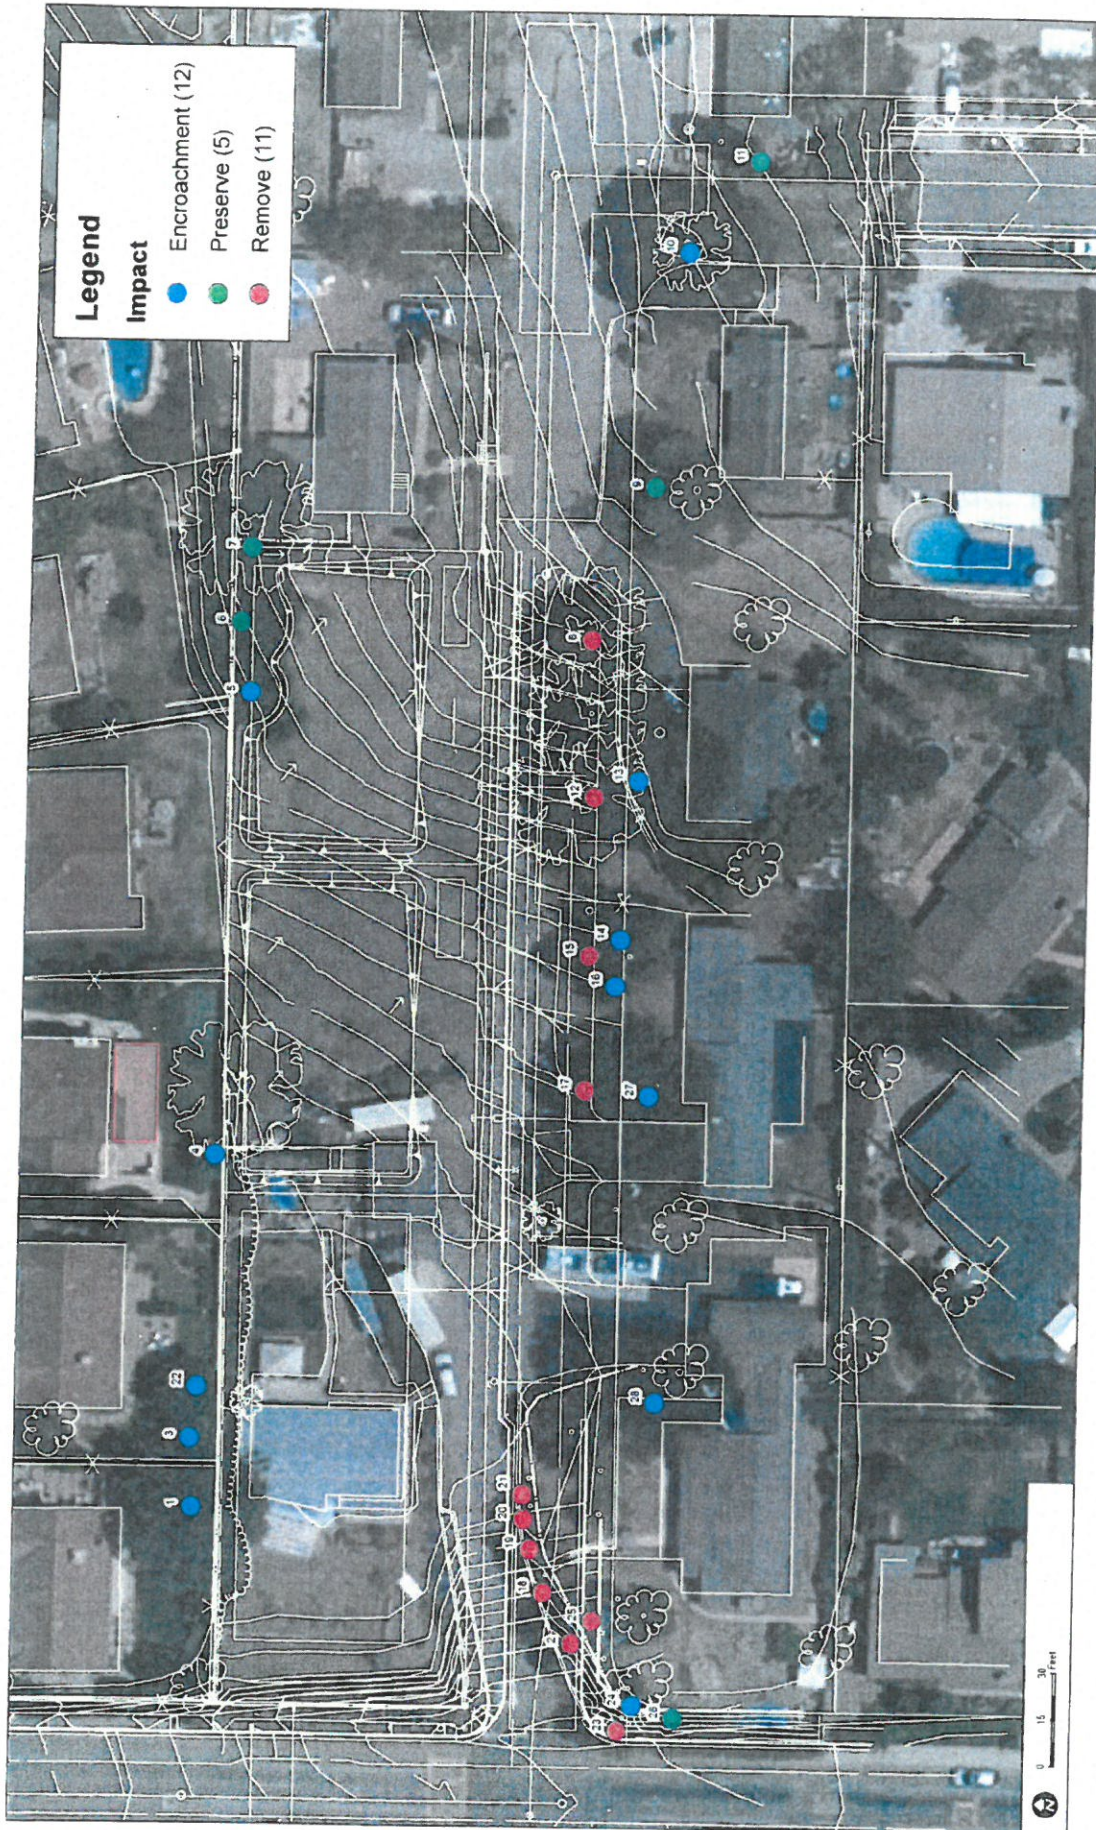
## *Tree Impact Exhibit*

Based on site observations, analysis of tree locations in relation to the Preliminary Grading and Drainage Plan (February 2017), and Dudek's experience working with trees on construction sites, Dudek arborists concluded that up to five trees can be preserved in place, 12 trees can be preserved in place with protective measures, and the remaining 11 trees will require removal. Table 1 provides a summary of trees in the project survey area by tree preservation status.

<b>Tree Preservation Status</b>	<b>Number of Trees</b>
Preservation	5
Preservation (Encroachment) – Protection Measures	12
Removal	11
<b>Total</b>	<b>28</b>

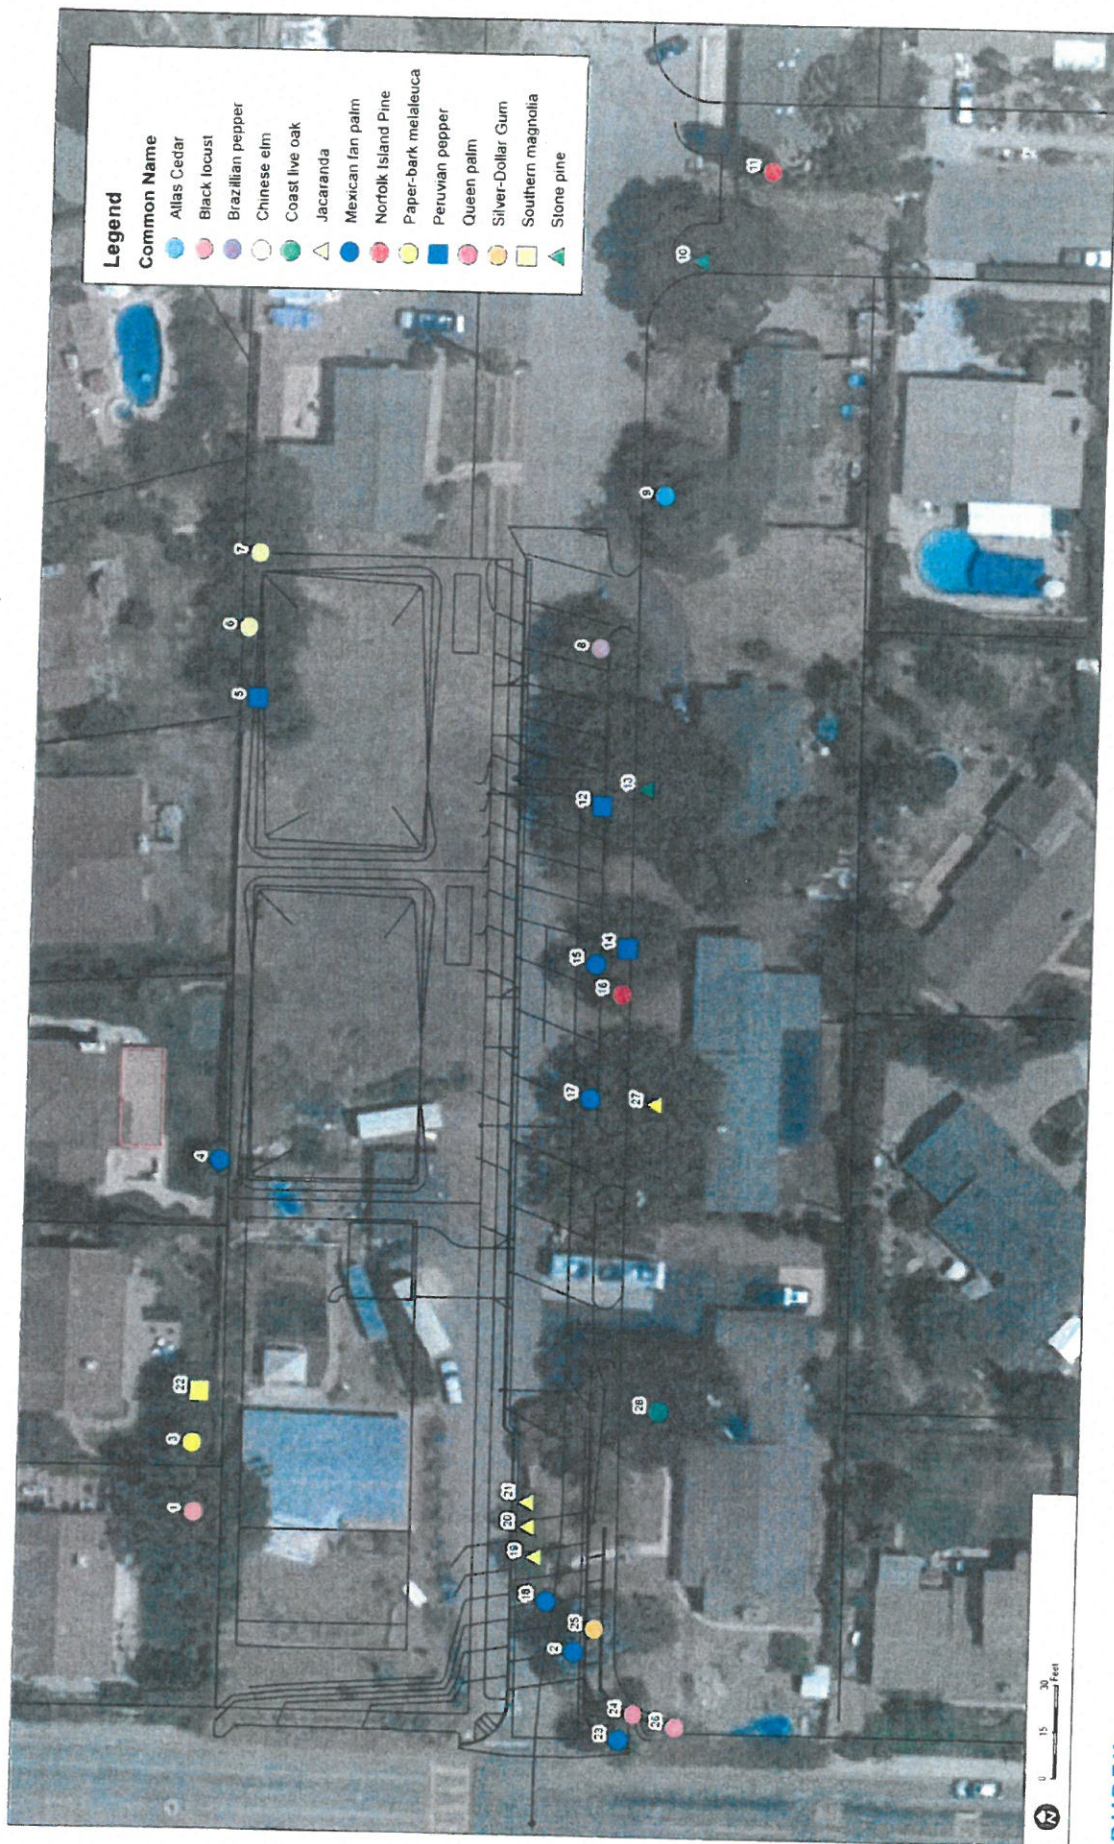
Attachment 3 - Tree Locations

Attachment 1 provides tree attribute details and preservation status for all trees located in the project survey area. Attachment 3, Tree Locations, shows the locations of the trees and impact status within the project survey area.
